Track 10- Before Santos Mining upgrade

Track 10- After Santos Mining Upgrade and the 2007 floods

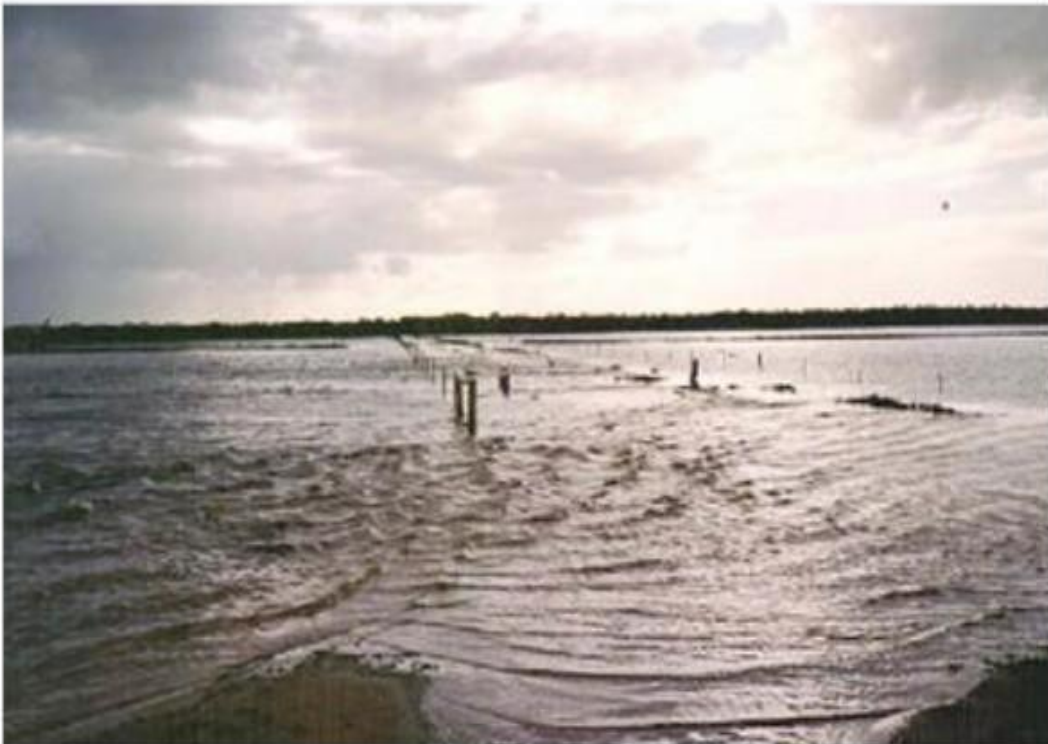
The below image, captured in 1995, predates the upgrade of Track 10 by Santos Mining. As a tidal causeway, vehicle access was restricted to periods of low tide at the time of the photograph.

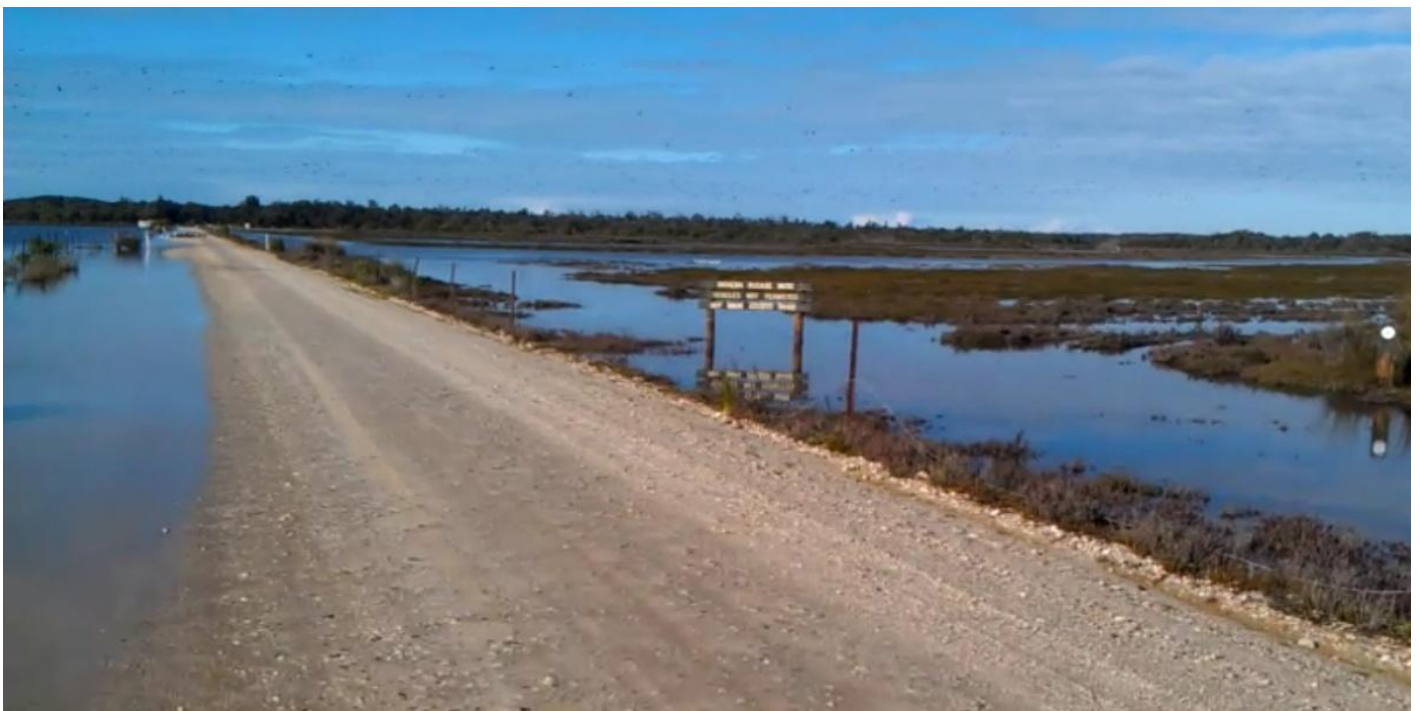
- **Image 1, 2 and video. – 2007 floods.** Unbalanced water level to the West of Track 10.
- **Image 3 – 2007 floods.** Balanced water levels on Stockhill Causeway are visible in the background. Including Lake Reeve flooding into Loch Sport.

Image 1- 2007 flood showing unbalanced water levels on Track 10. 90 Mile Beach in the background

- The 3 culverts on Track 10 causeway should be at least the same or larger than diameter the culverts on Stockyard Hill to allow a matched water flow.

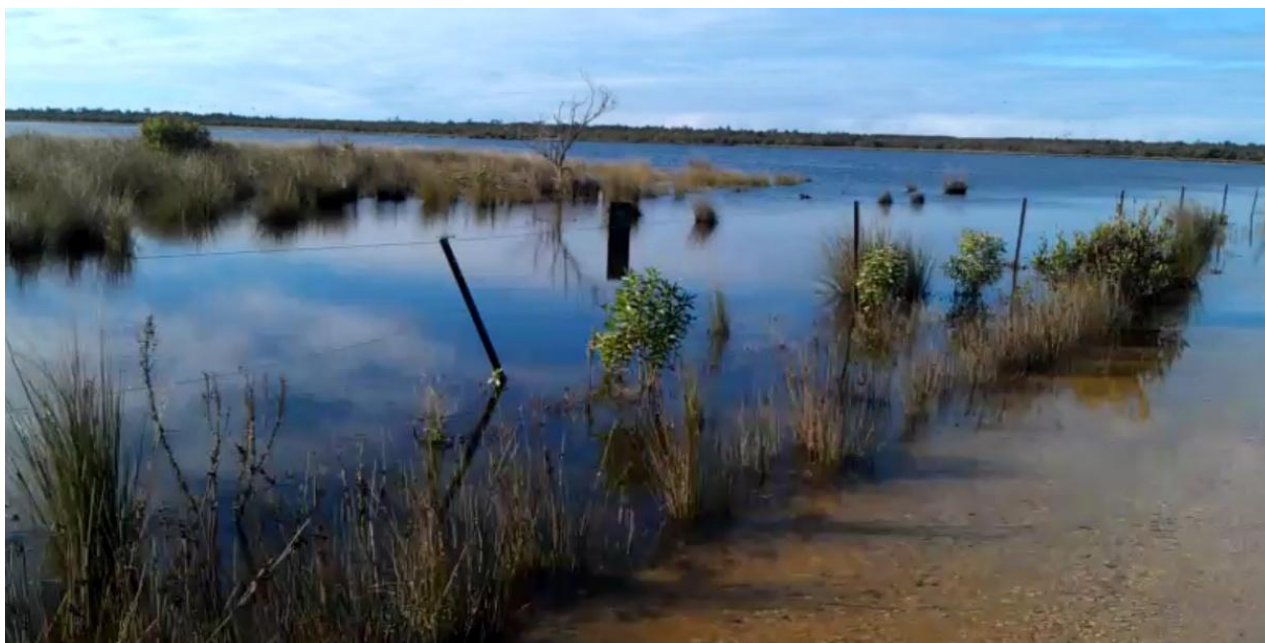
Images 2

2007 floods showing unbalanced water levels on Track 10. 90 Mile Beach in the background.

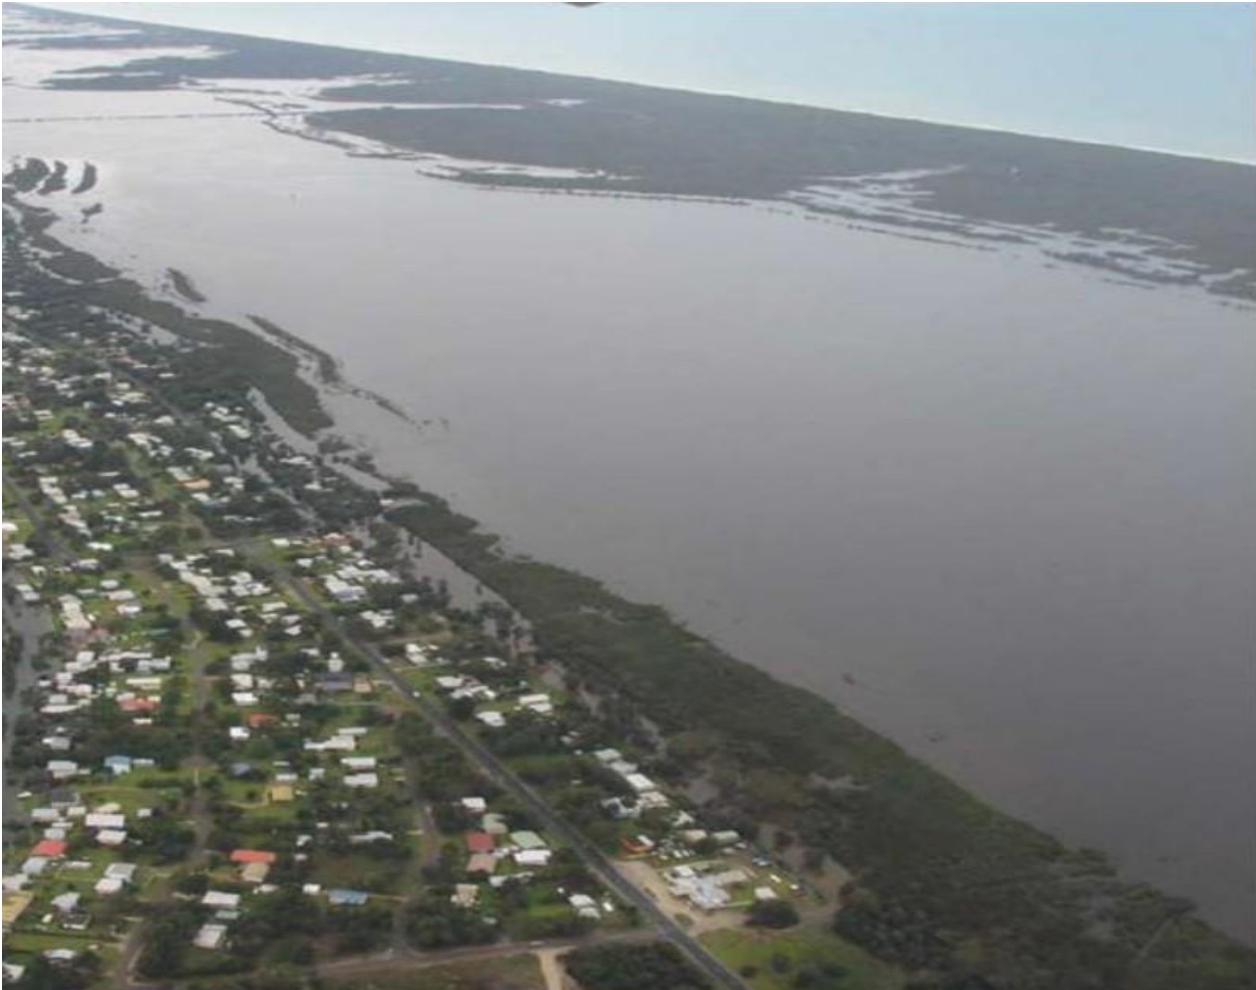
Image 3

2007 floods water level of lake Reeve flooding into Loch Sport. Track 10 restricting the flow of water west toward Seaspray. Note balanced water level with Stockyard Hill causeway in the background.

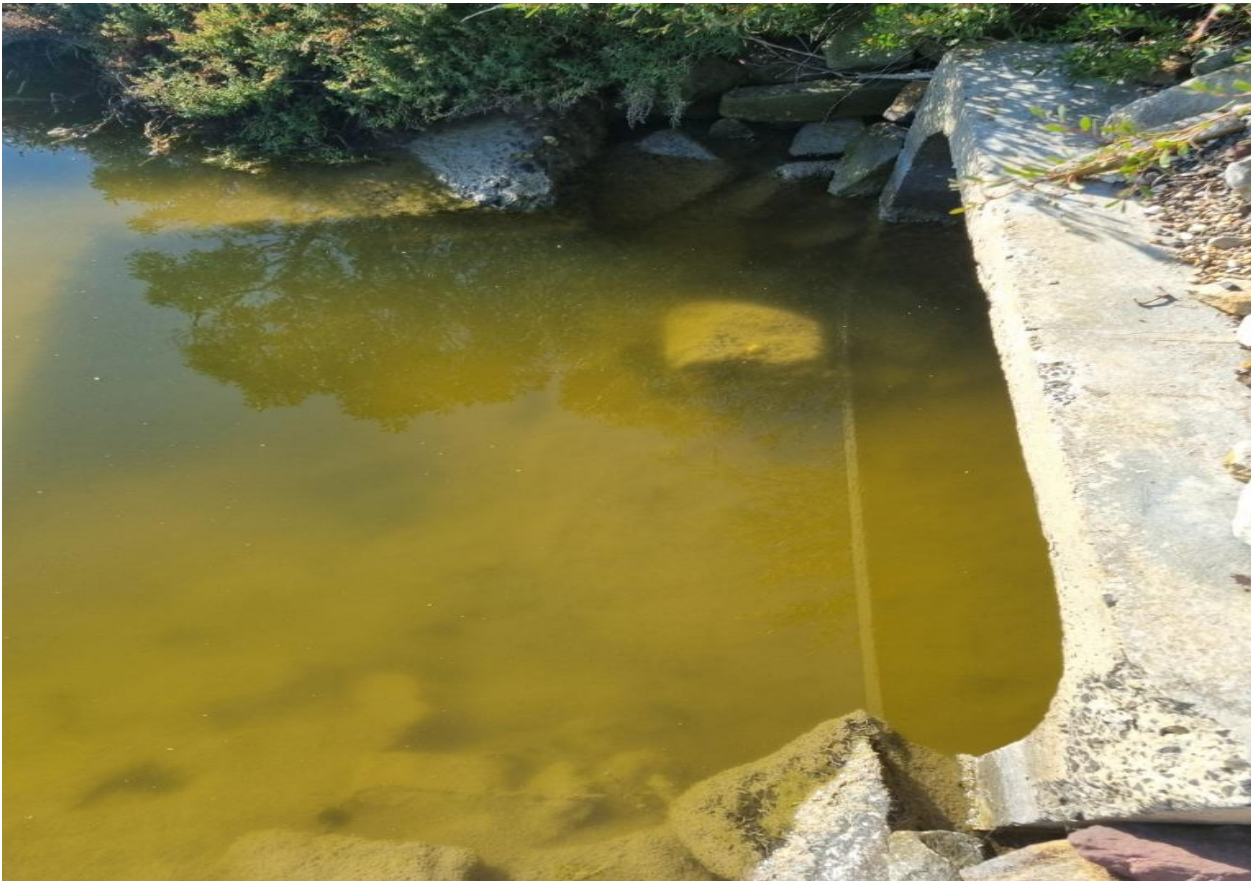
- **Image 4-** The culvert installation on the Stockhill Causeway has facilitated an accelerated water flow towards Track 10.

Image 4- The culvert installtion on the Stockyard Hill causeway has allowed for a faster water flow towards track 10
